Reducing Motor Bearing Failures – Modified Lubrication Procedures Improve Reliability at TVA

Jerry Honeycutt,
Tennessee Valley Authority

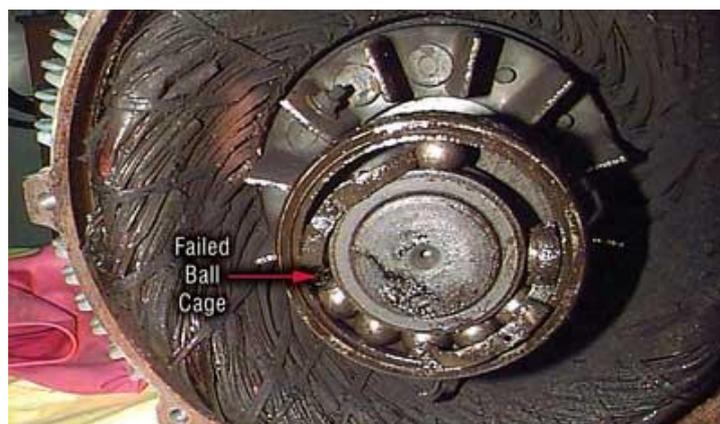
An example of a bearing failure due to bearing shields being pushed into the raceway as a consequence of overgreasing is shown in Figure 1.

This was a control rod drive (CRD) fan motor at Watts Bar Nuclear Plant. The bearing experienced a ball cage failure due to the bearing shield (Figure 2) being pushed down on the ball cage due to overpressurization of the grease cavity.

Install a pressure-sensitive (20 psi differential) grease-fill fitting that will not allow the cavity to be pressurized beyond 20 psi. This should minimize excessive pressure buildup on the bearing shield while the motor is being regreased.

Install a grease-relief valve-fitting to take the place of the grease drain plug. The grease-relief valve will open between 1 and 5 psi and will minimize risk of over-pressurization of the grease cavity from re-lubrication and thermal expansion of the grease (while running the motor).
