Report Date: May 22, 2012

Product: **Pulsarlube M 125cc/PL1**
Industry: Energy (Public)
Customer: **KDHC (Korea District Heating Corporation)**
Application: **Cooling Tower**
Installation: January 9, 2012

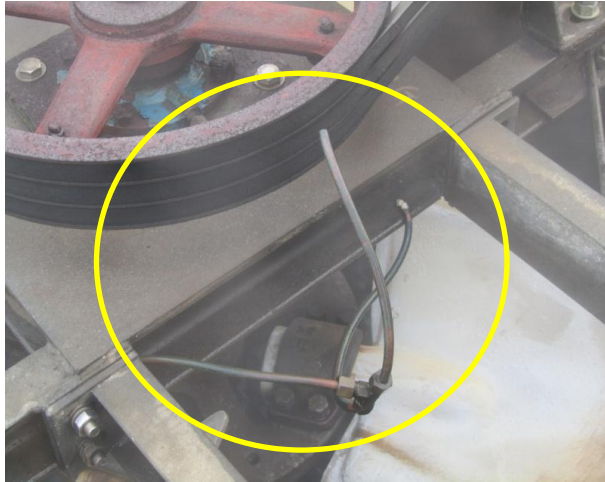
Before Pulsarlube:

On the top area of the cooling tower, there is a T-valve installed to lubricate both top and bottom bearing via copper tube. We observed that the lube line is gone (found the signs of fracture) and no lubrication has been applied at all.

T-valve with broken lube line

T-valve is dismantled and two units of the Pulsarlube M 125cc filled with PL1 installed on the top area of the cooling tower. New copper tube has also replaced old broken lube line for remote installation.

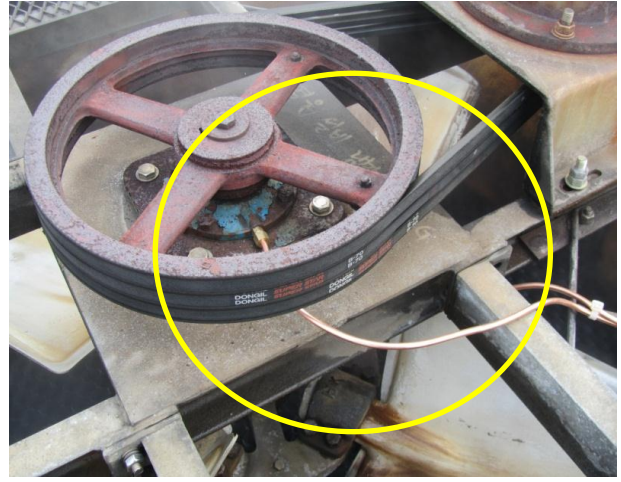
After Installation:

New lube line without T-valve

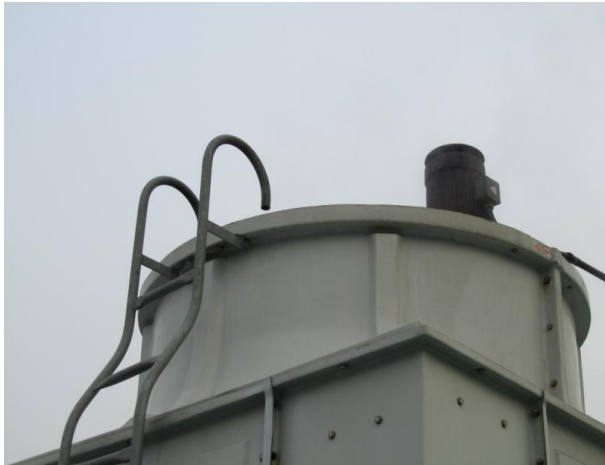
No lubrication device

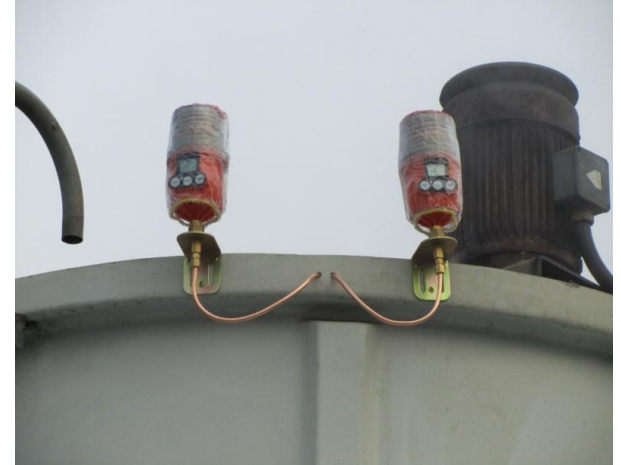
Two Pulsarlube M 125 units installed
